10e – Lightwood Road, Marsh Lane Bus Shelter

- Lightwood Road opposite Bramley Road

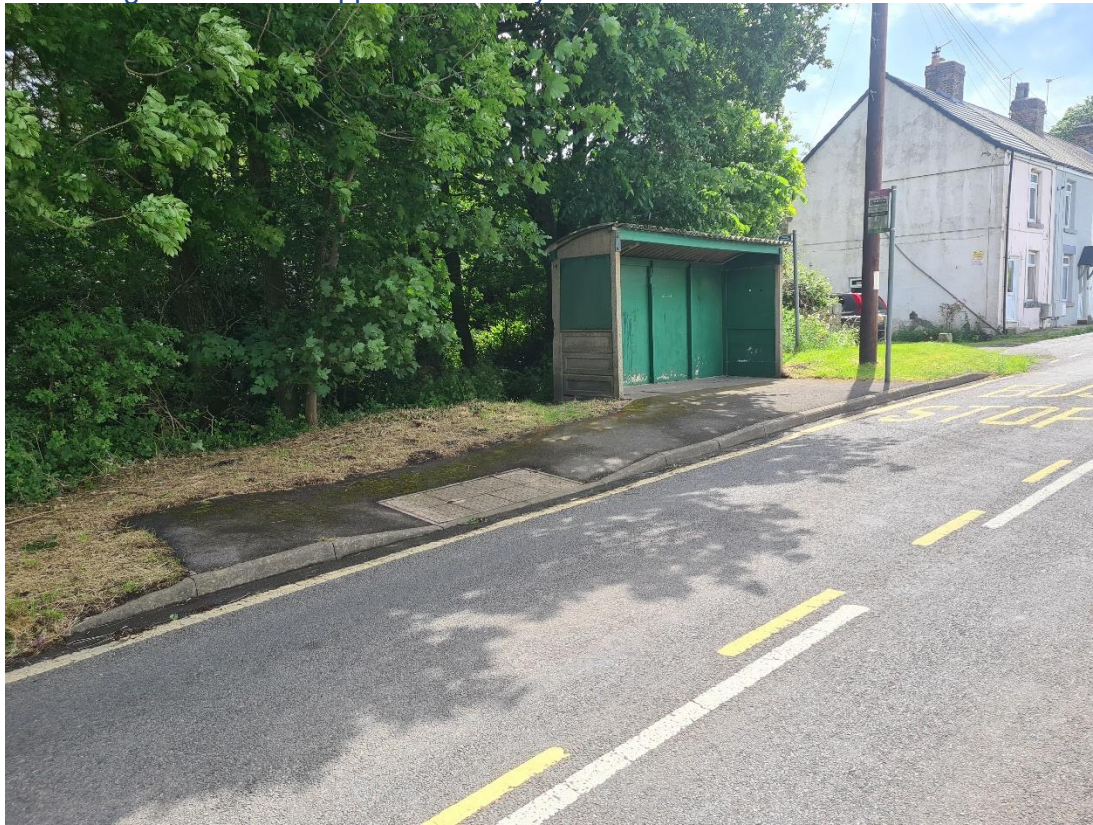
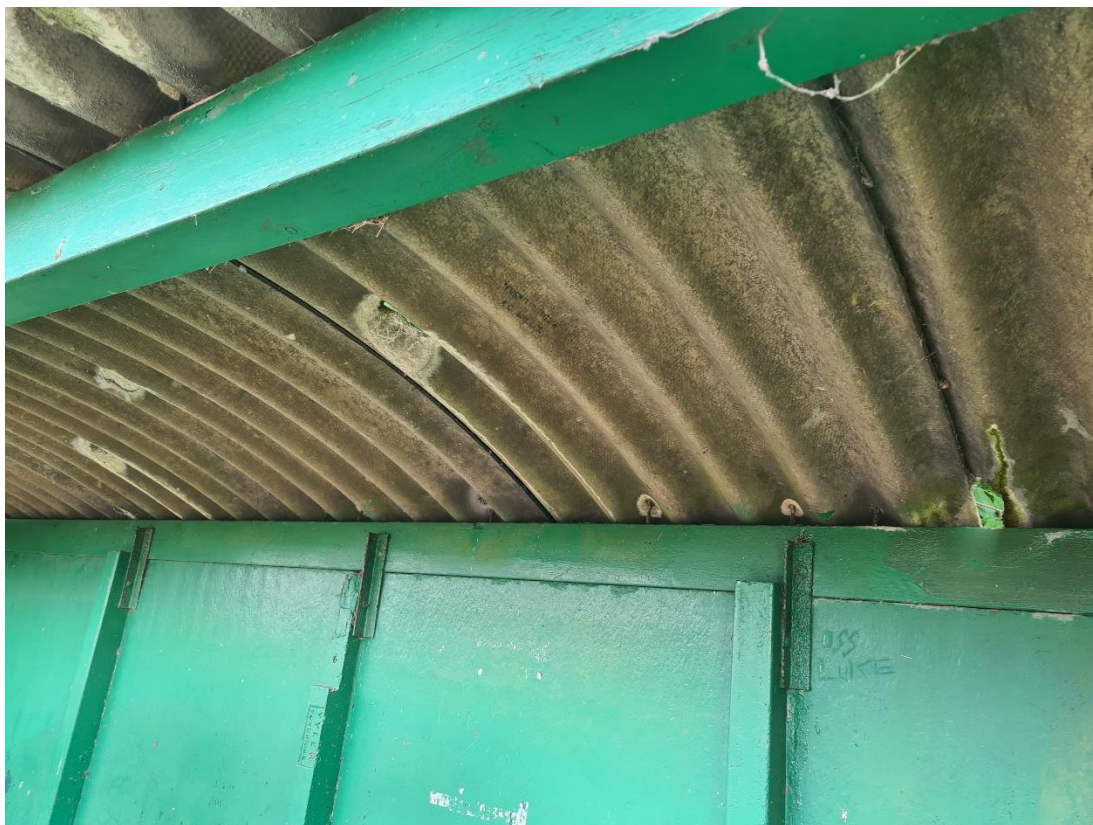
The roof of this older shelter is in a very poor state with holes in what appears to be an concrete/asbestos ridged panel roof, the shelter and boarding point also fail to meet latest accessibility standards.
